# PERFORMANCE OF STEEL TANKS IN CHILE 2010 AND 1985 EARTHQUAKES

*Patricio Pineda  
G. Rodolfo Saragoni  
Elias Arze Loyer (†)*

**UNIVERSITY OF CHILE**

**January 2012**

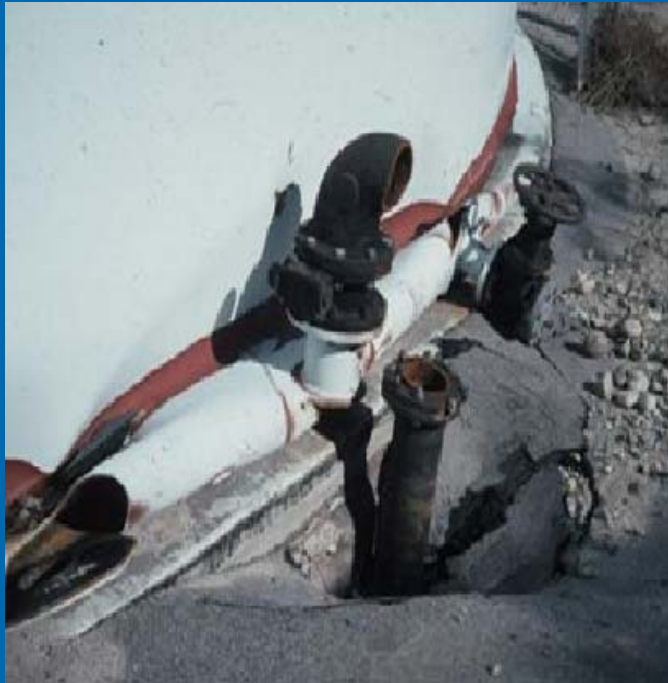
**Rupture of Pipes**

- Tanks shown above are self-anchored
- Mainly designed according to API 650-E (1980)
- Must be review design criteria for self-anchored tanks

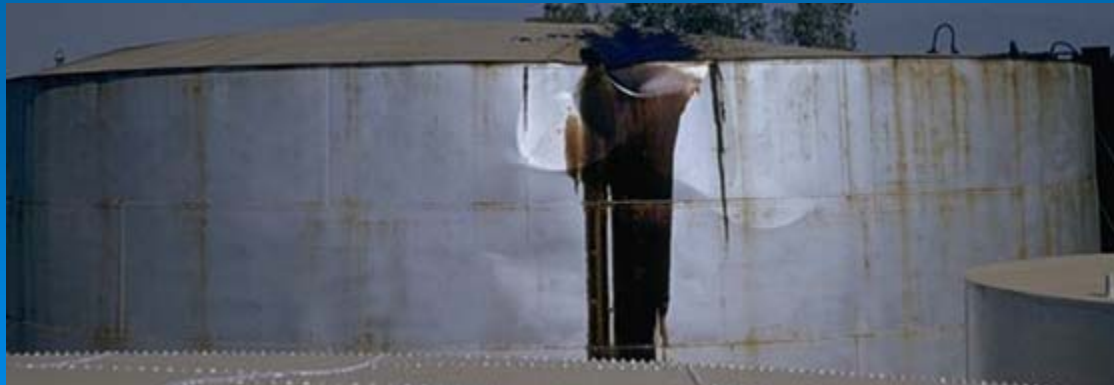
**Failures in Joints Wall – Roof**

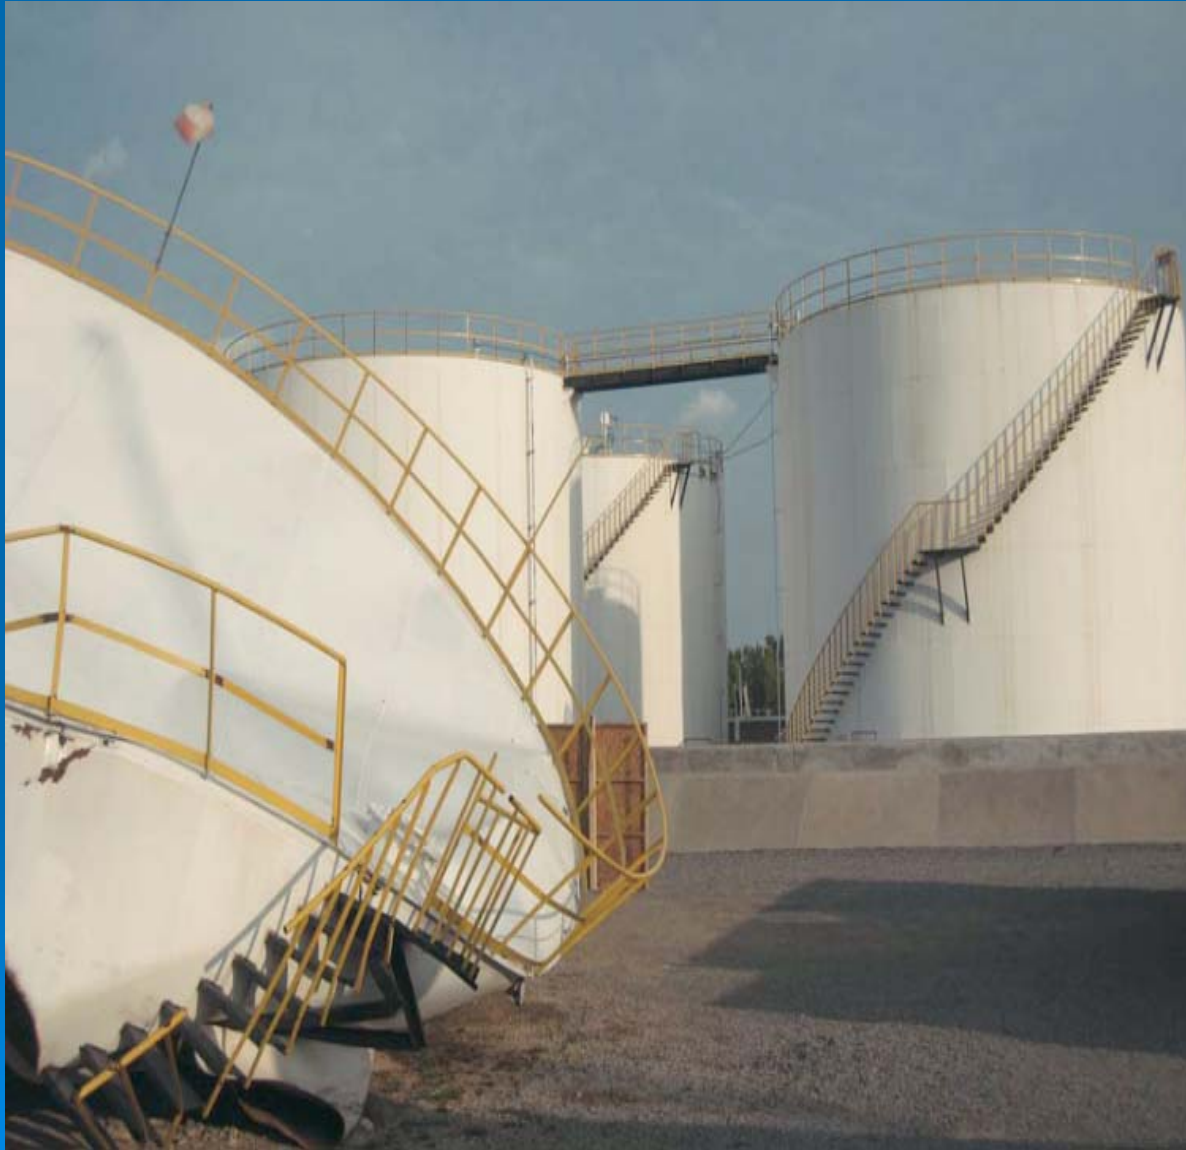
# SANTIAGO INTERNATIONAL AIRPORT

- Capacity: 1300m<sup>3</sup>
- Collapse
- Self-Anchored
- Full when earthquake occurred
- We assume design problems
- Undamaged tanks near
- Far away from the epicenter

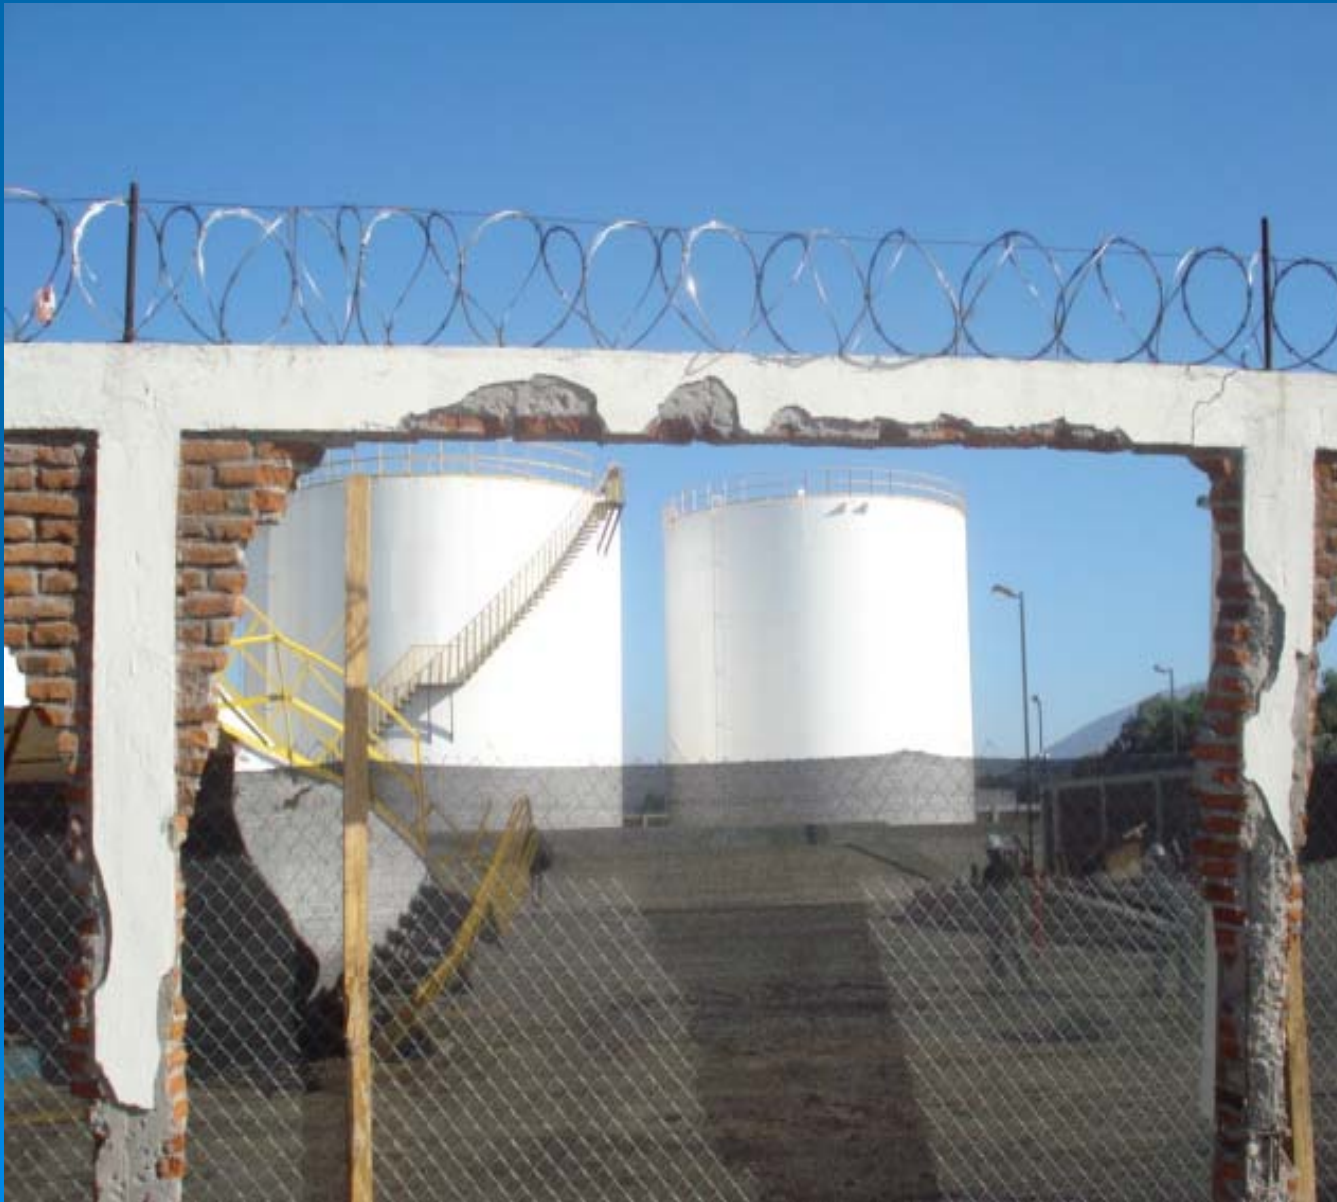
# SANTIAGO INTERNATIONAL AIRPORT MASONRY DROP FORCE WATER

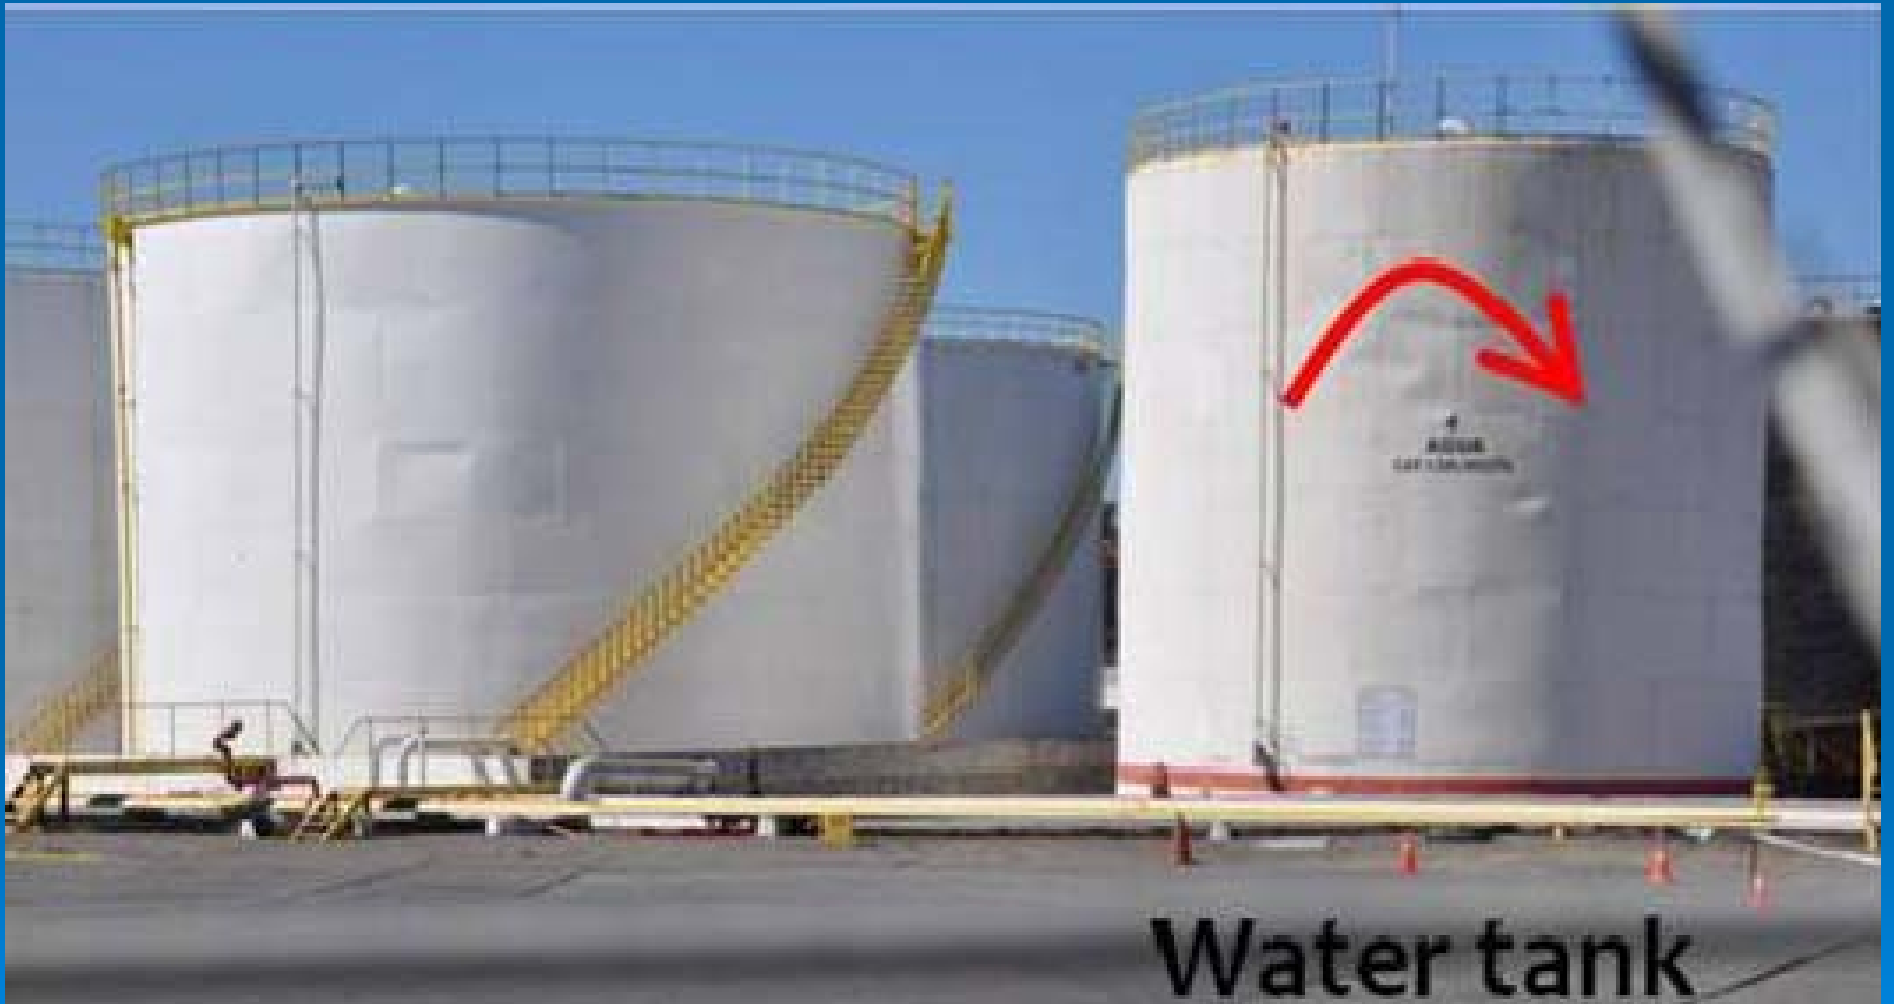
# PORT AT CONCEPTION AREA TILTED ONE DEGREE

**Near the Epicenter**

- Tank performed well due to use mechanical anchor recommended by NCh2369.Of2003 Chilean Standard
  - Steel tanks were located in industrial and oil zones of Chile
  - Seismic recorders were located near the epicenter
-
