# BACKWARD SEISMIC ANALYSIS OF STEEL TANKS

Patricio Pineda Nalli  
G. Rodolfo Saragoni  
UNIVERSITY OF CHILE

**STESSA'15**

The 8th International Conference on Behaviour of Steel Structures in Seismic Areas

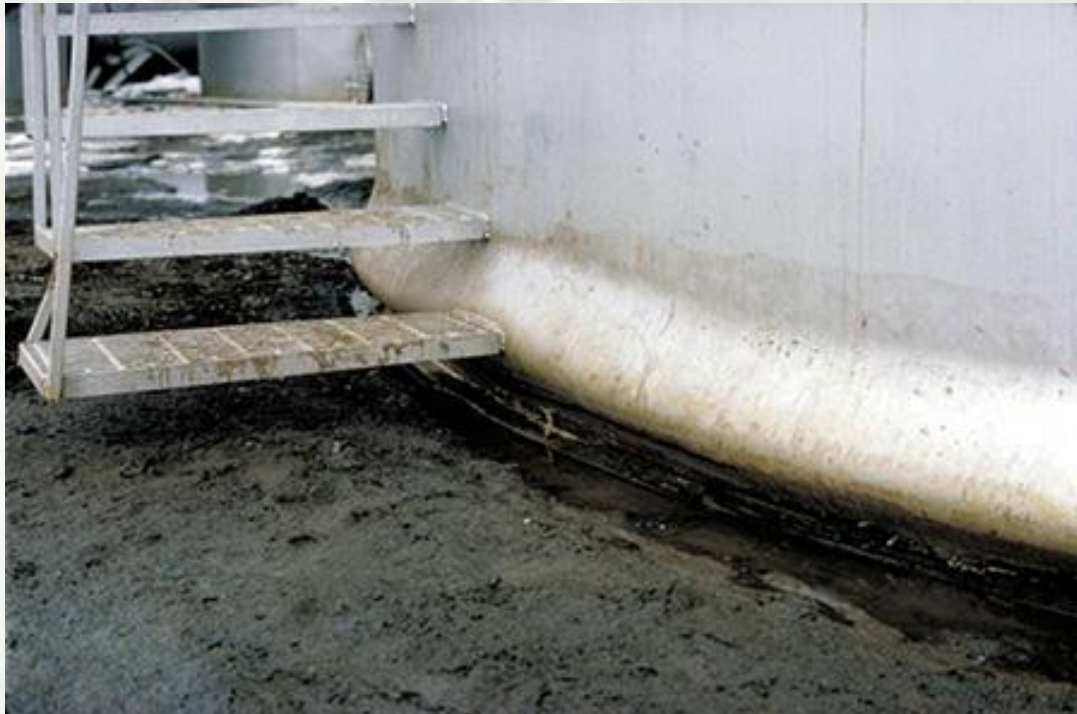
**Buckling Shell**

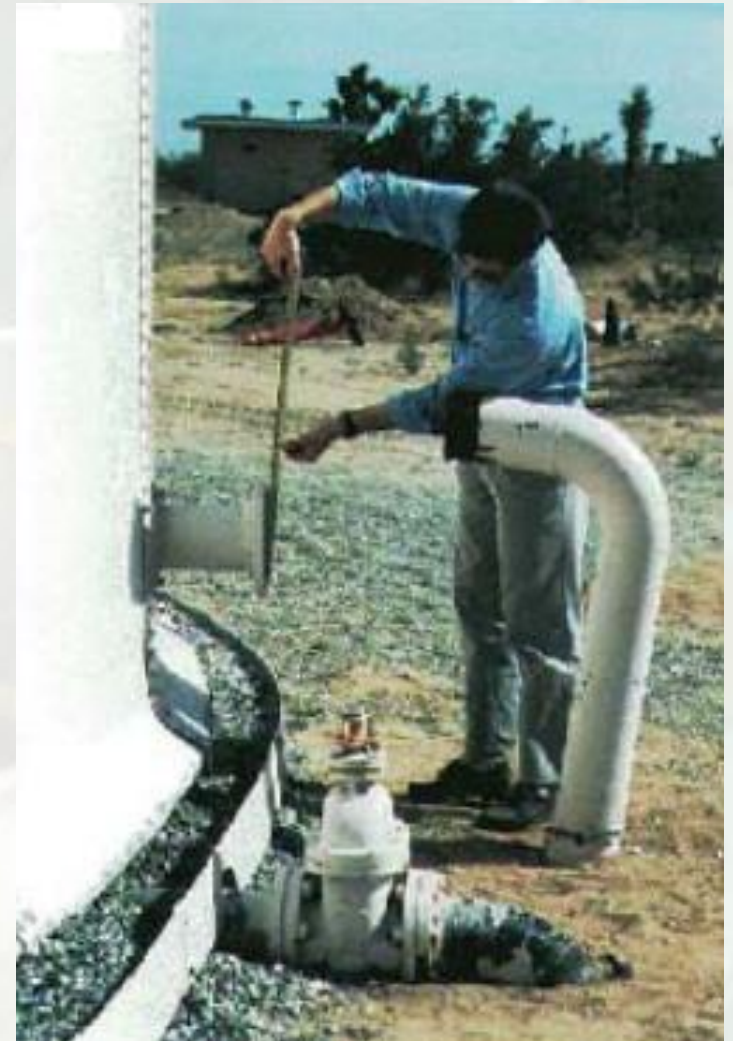
**Horizontal Sliding**

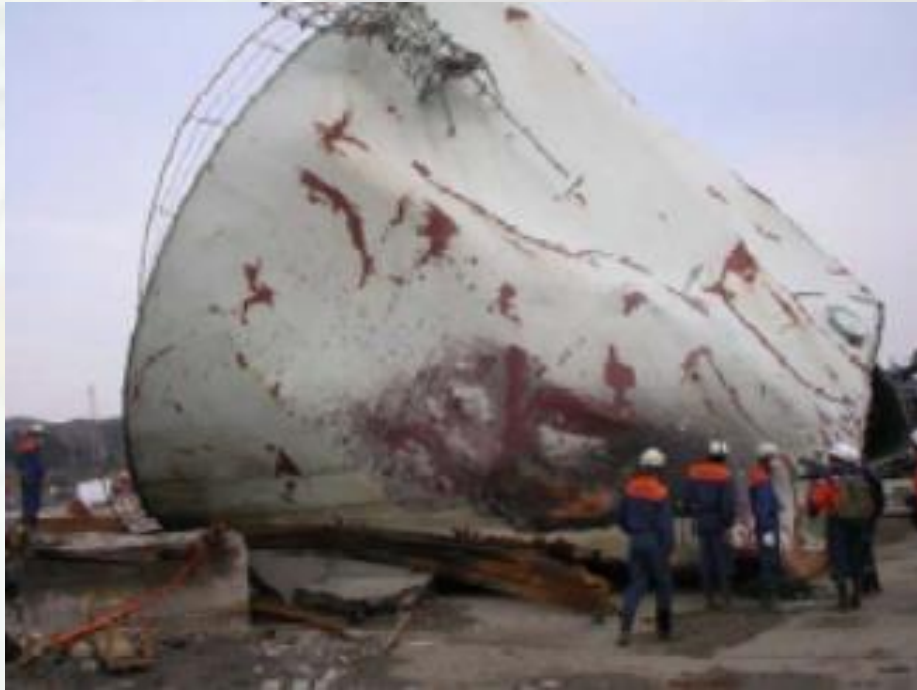
**Collapsed by the Tsunami**

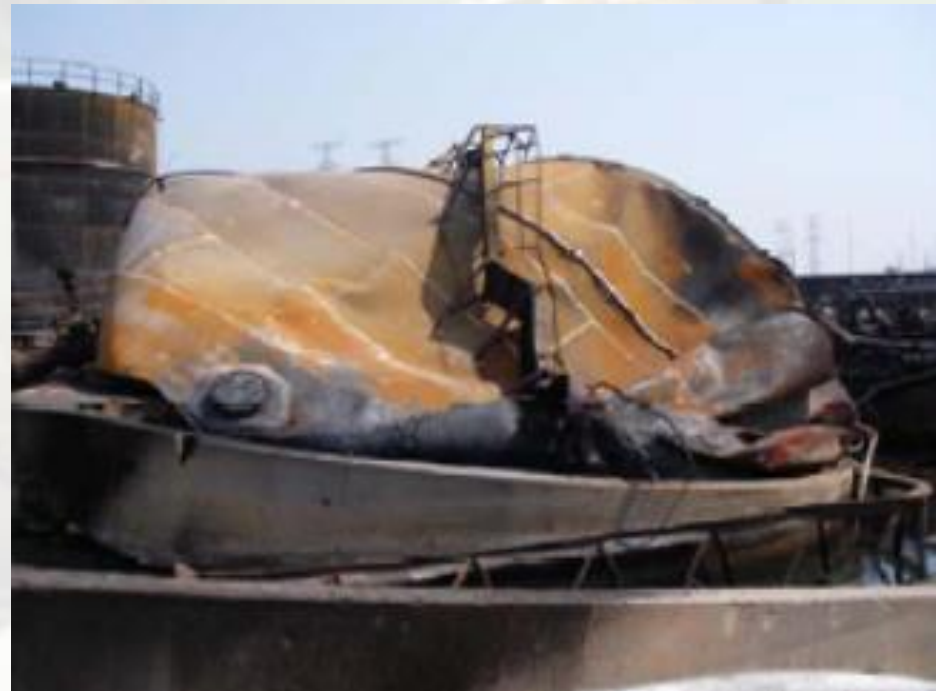
**Burned-out gasoline tank**

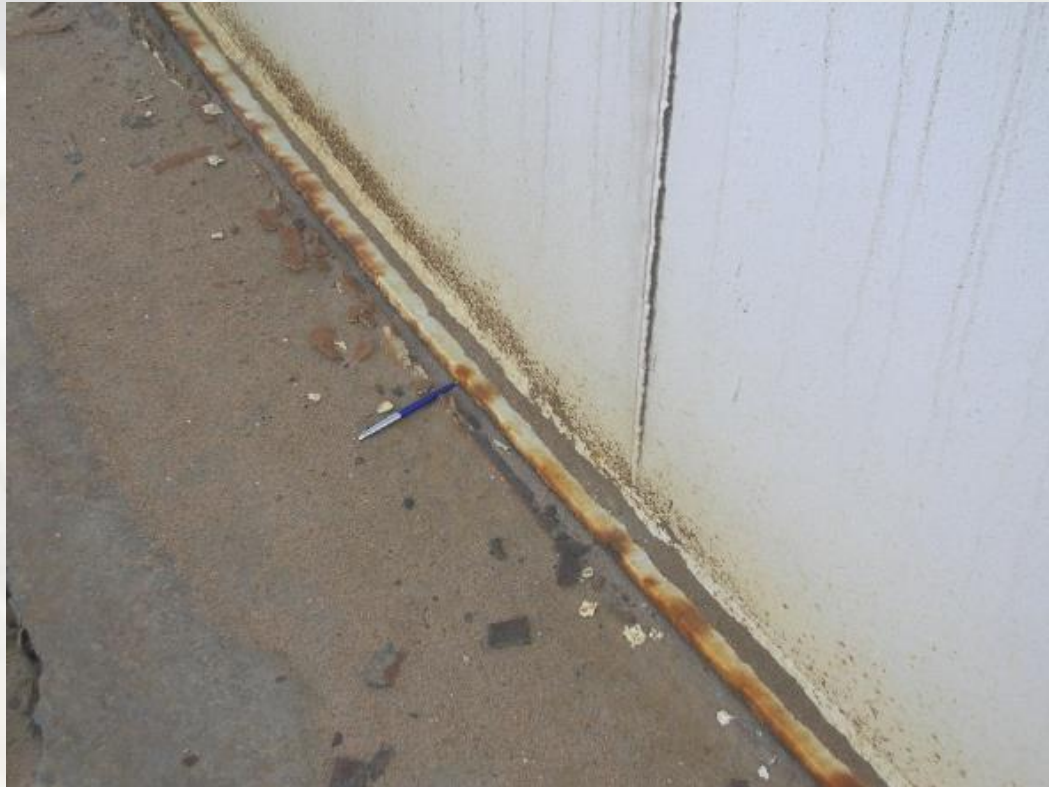
**Buckling “elephant foot”, lifting of base of 80mm**

**Horizontal sliding (100mm) in perpendicular direction to the coast, in convergence direction of subducted Nazca plate**

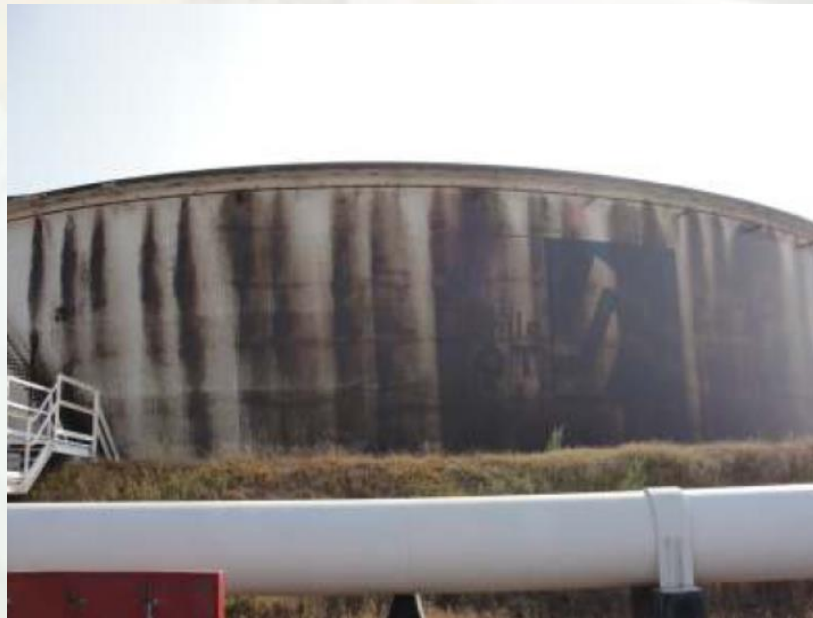
**Spilled oil**

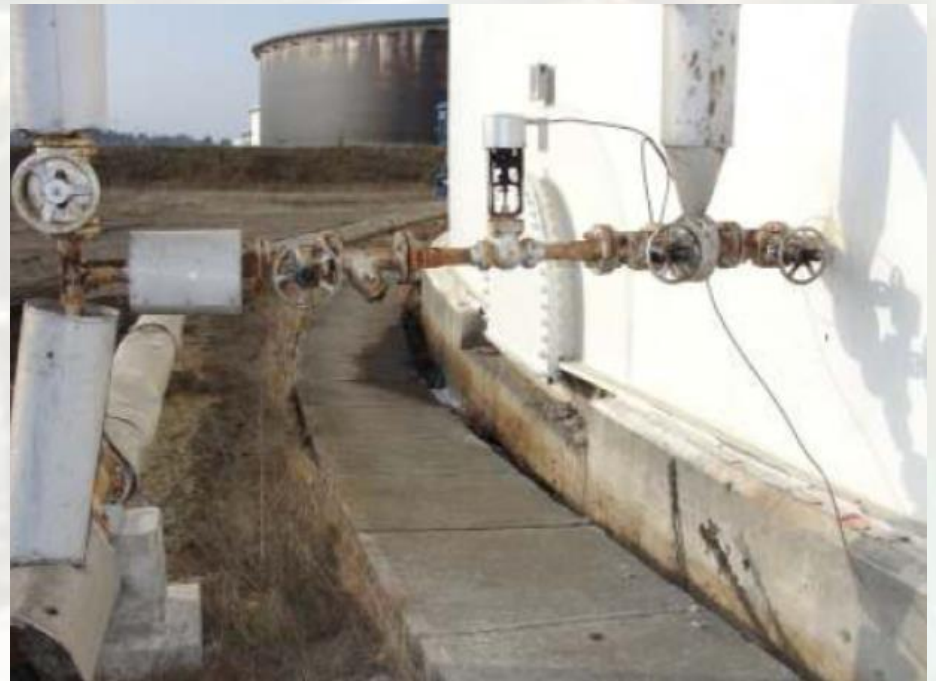
**Lateral spreading and soil  
liquefaction**
