ANALYSIS OF STEEL TANKS IN CHILE SUBDUCTION EARTHQUAKES

Patricio Pineda Nalli

G. Rodolfo Saragoni

January 11, 2017

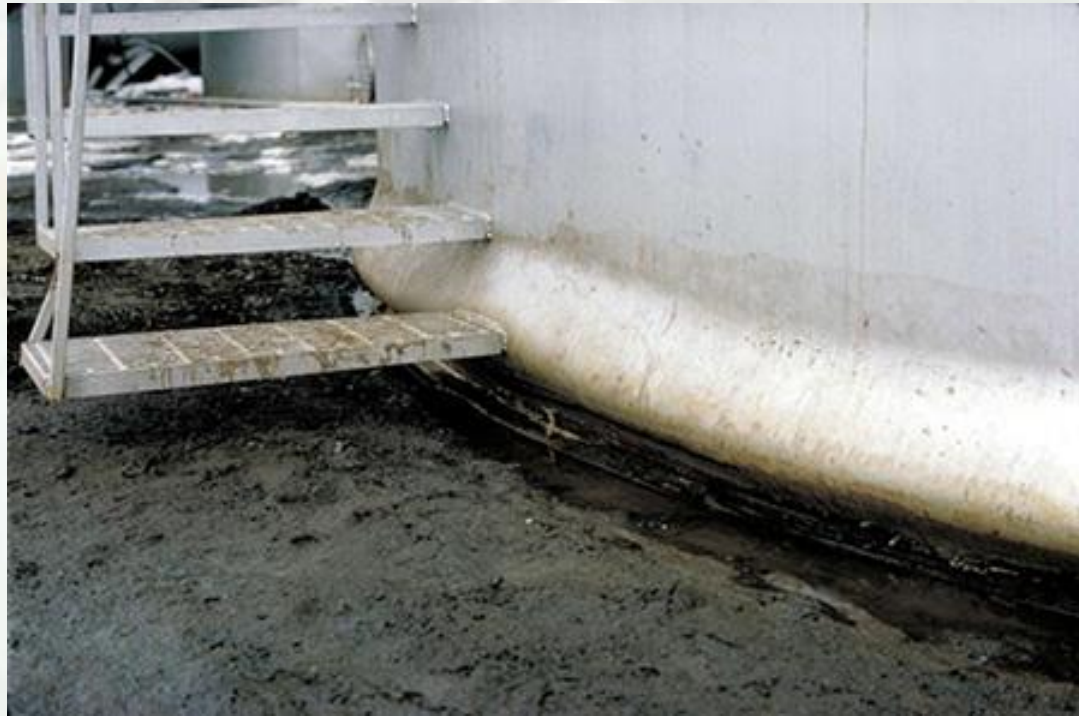
Buckling Shell
(BS)

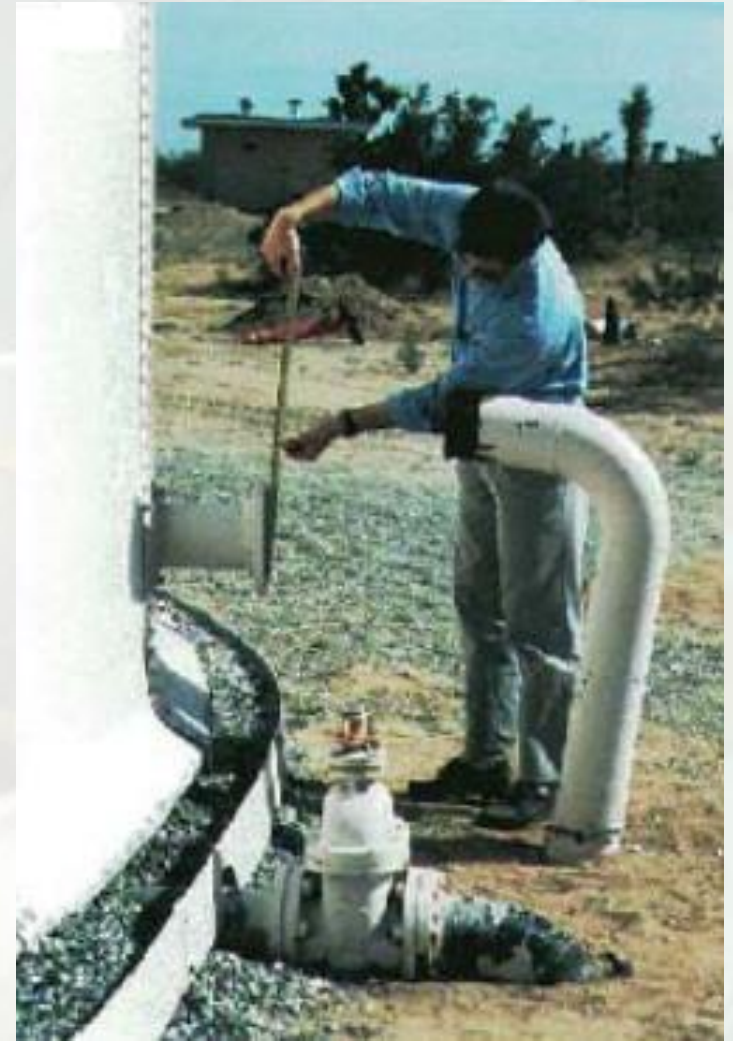
Horizontal Sliding
(HS)

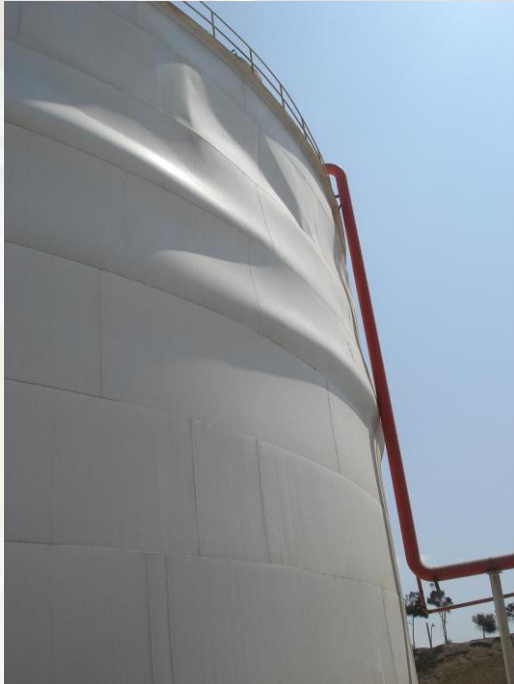
**Buckling
Shell**

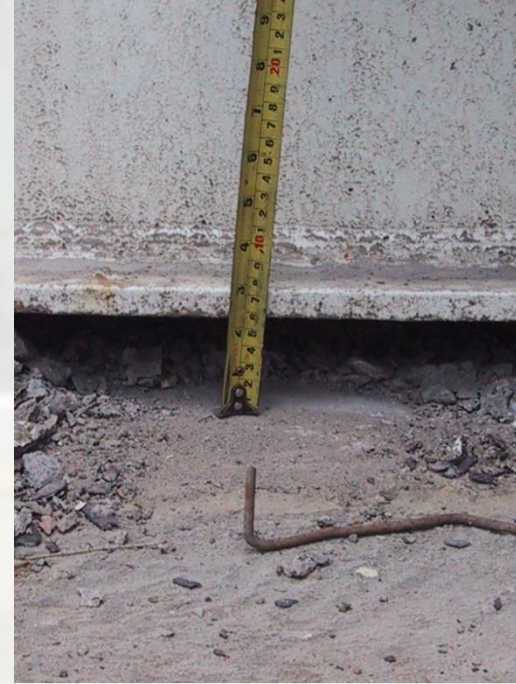
Uplift

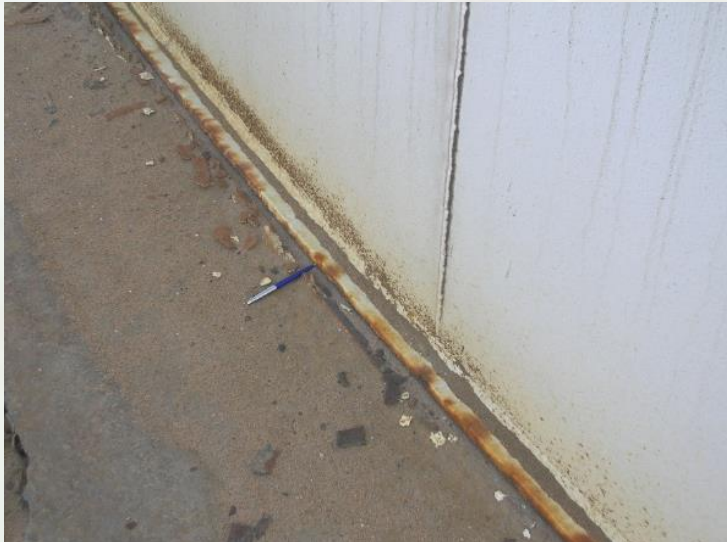
**Horizontal
Sliding
(±100mm)**

**Requires
Anchor Bolts**

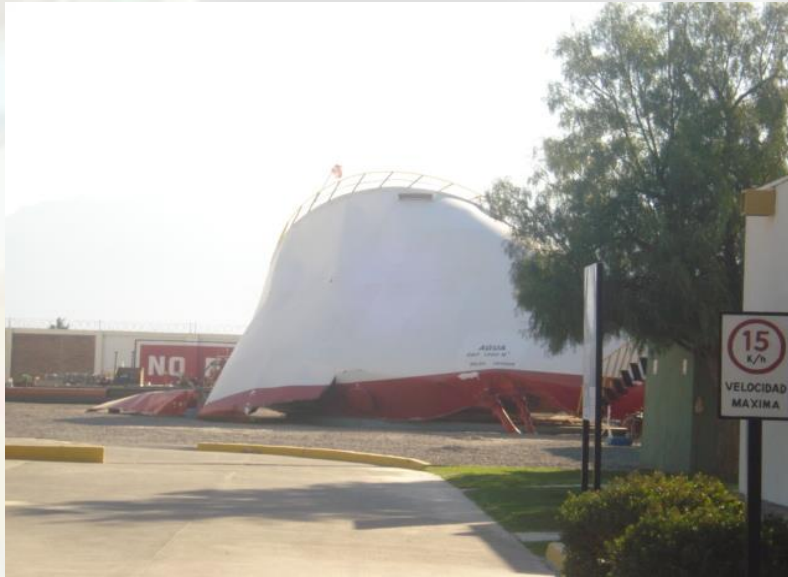
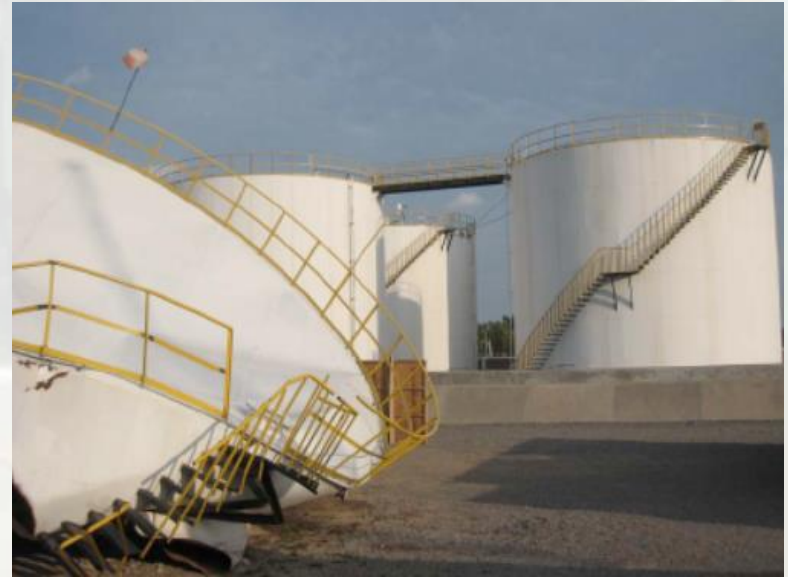
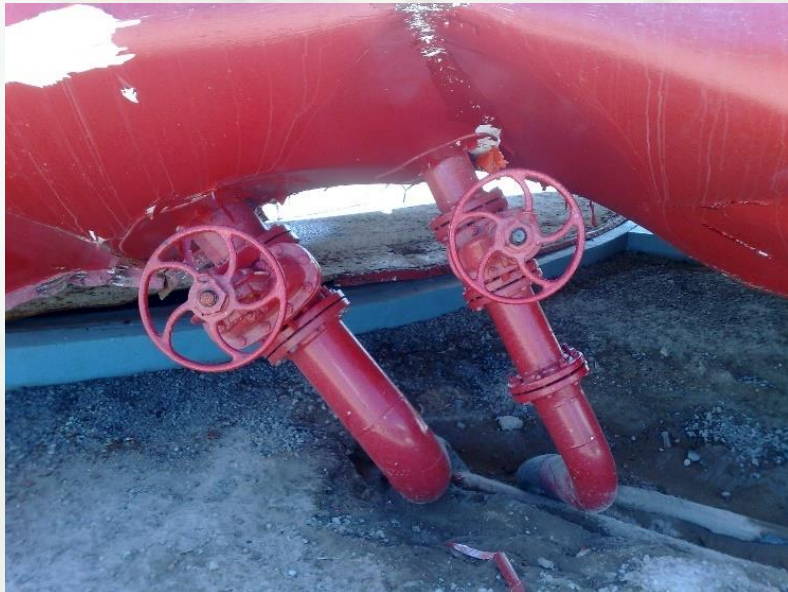
Only collapse the self-anchored tanks

Rigid connections piping

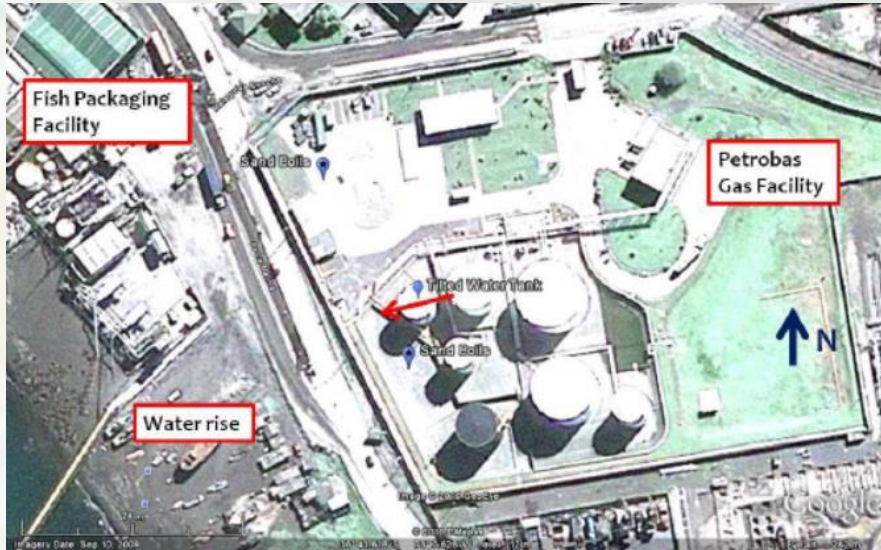
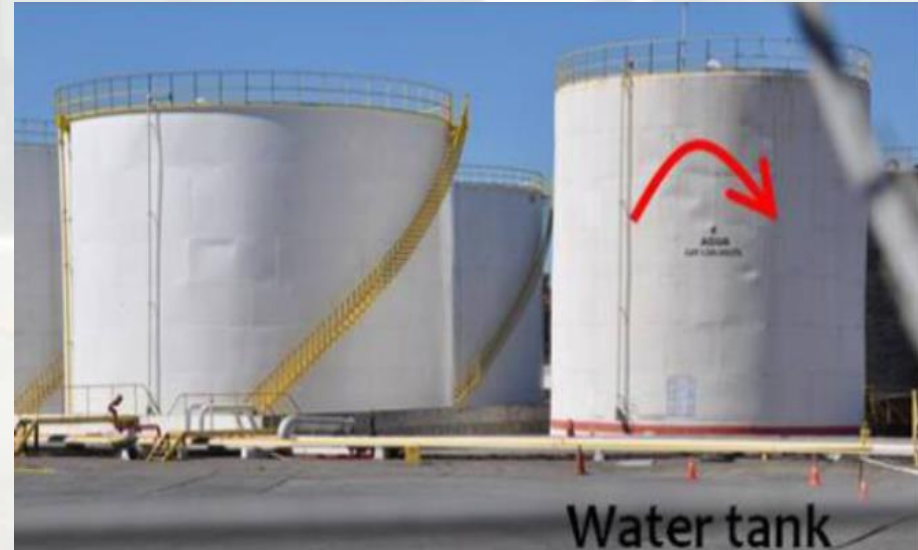
Tanks near epicenter
No evidence of damage
Tilted one degree
Seismic directivity

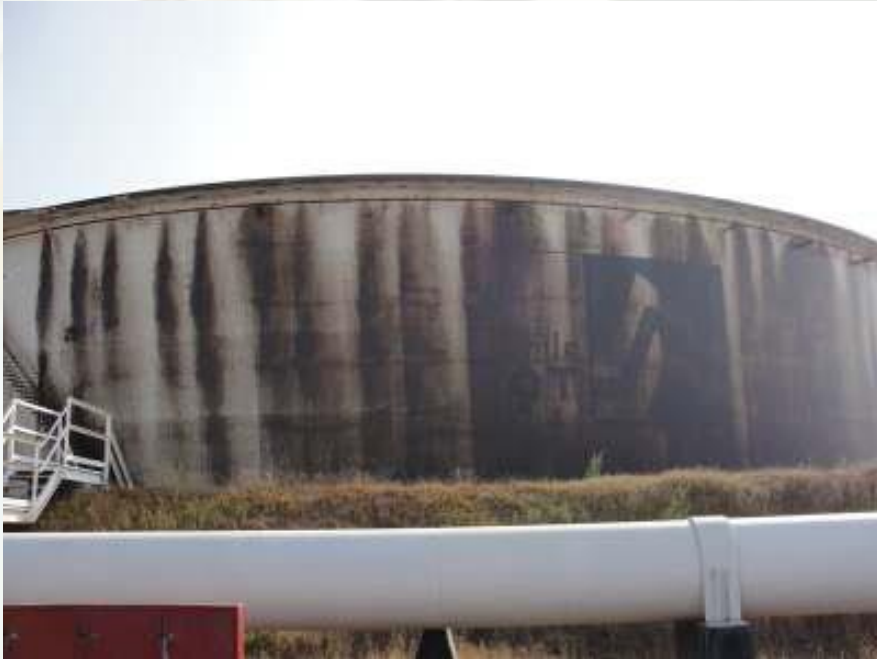
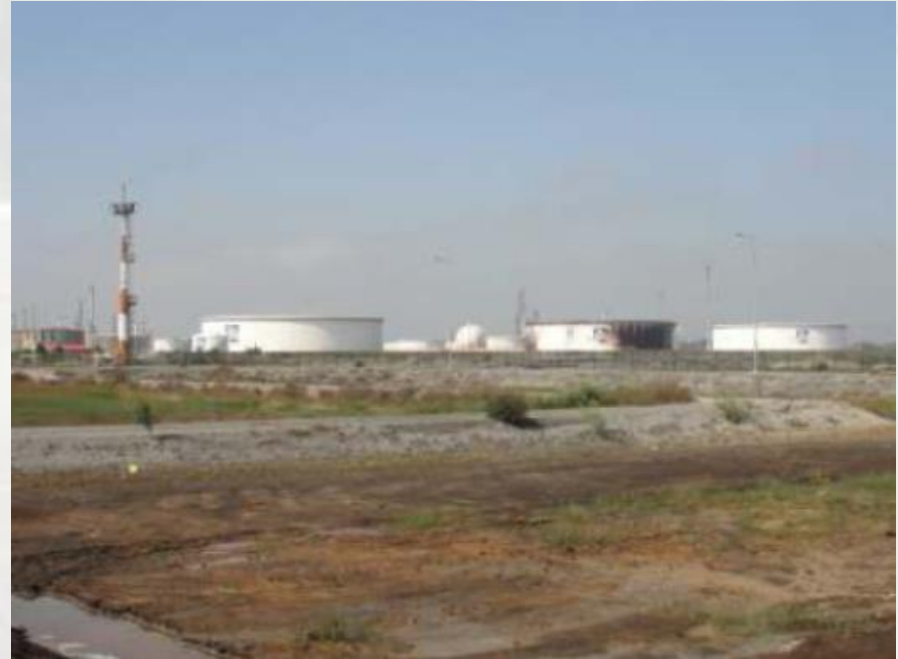
Evidence of Sloshing

**Must be controlled:
Height of Filling & Freeboard**
