# PERFORMANCE OF STEEL TANKS IN CHILE 2010 AND 1985 EARTHQUAKES

*Patricio Pineda  
G. Rodolfo Saragoni  
Elias Arze Loyer (†)*

**UNIVERSITY OF CHILE**

**January 2012**

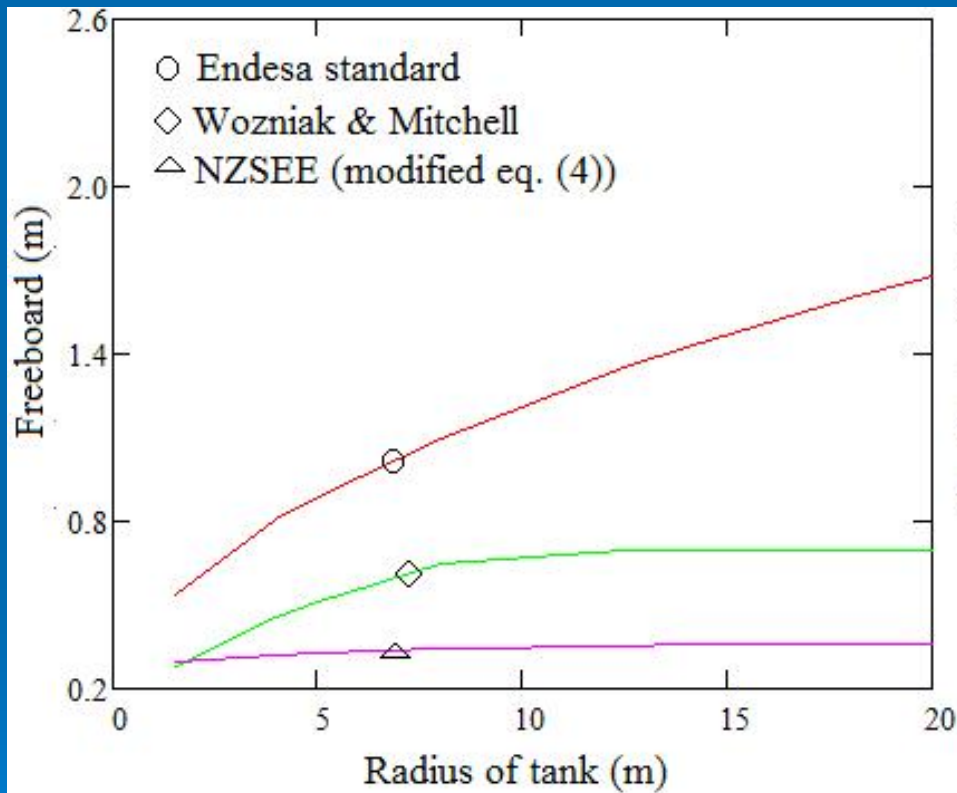
## Freeboard

Large Dispersion

- In Official Chilean Standard NCh2369.Of2003,  $R_c=4$  must be corrected for  $R_c=1$  (Convective Mode)
- Investigate methods for calculating freeboard with reasonable values due to large dispersion
- Must consider imperfections in formula for buckling stress
- Instrumentation is strongly recommended for tanks

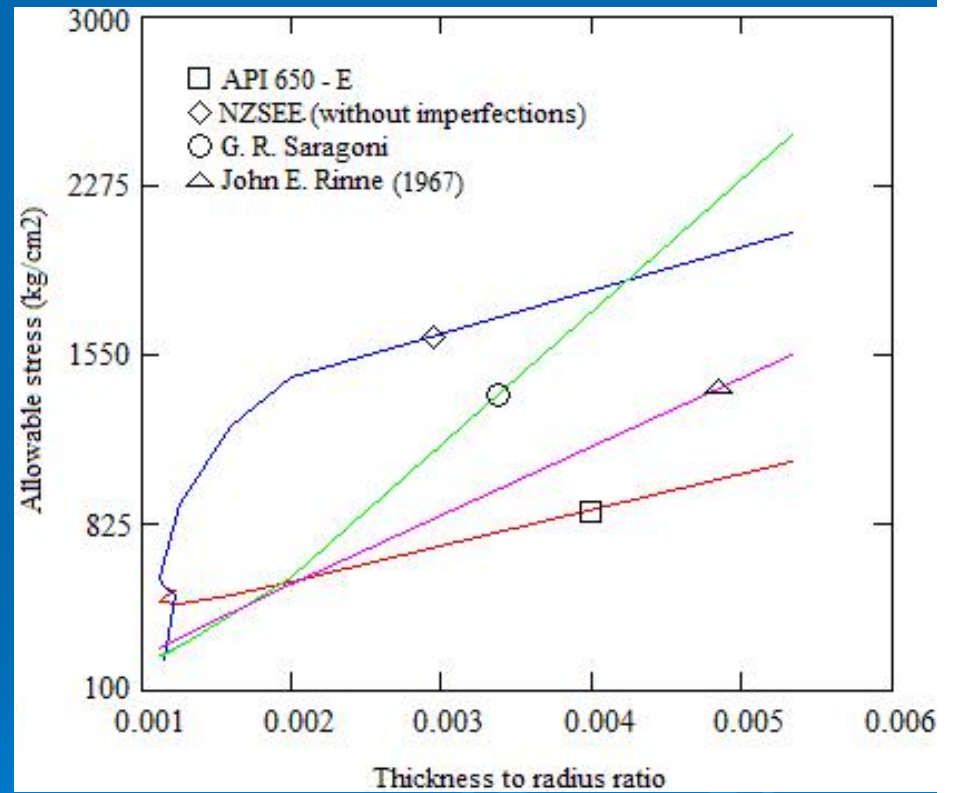
## Allowable Stress

Imperfections in Shell
